Northbridge Park; Site CW3

CREEK WATCHER REPORT CARD Pitt Street Bridge; Site CW13								
	Standard Score Grade Grading System							
Dissolved Oxygen	> 4 ppm	66.7%	D	А	90-100			
Secchi Depth	> 30 cm	100%	Α	В	80-89			
pH	6.5-8.5	100%	Α	С	70-79			
Temperature	< 32.2°C	100%	Α	D	60-69			
Debris at Site		None	Α	F	0-59

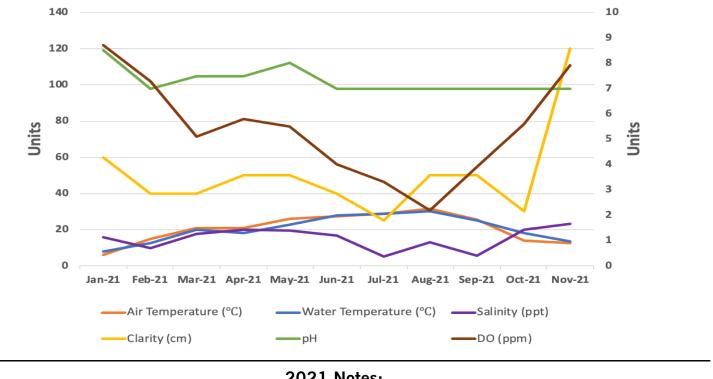
Standard	Score	Grade	Grading System	
Dissolved Oxygen	> 4 ppm	63.6%	D	Α	90-100
Secchi Depth	> 30 cm	90.9%	Α	В	80-89
рН	6.5-8.5	100%	Α	С	70-79
Temperature	< 32.2°C	100%	Α	D	60-69
Debris at Site		No debris 3/11	F	F	0-59

- Muddy water at Northbridge Park year round
- Debris found frequently throughout the year
- No nurdles at this site!

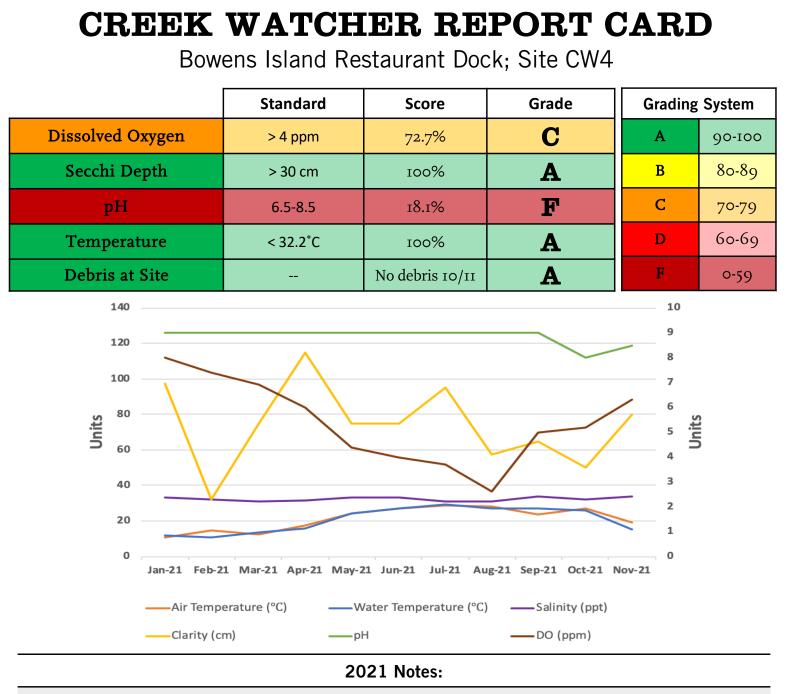
- Mostly clear water through out 2021 sampling
- A few waterfowl and many oysters found at CW4 this year!
- Green vegetation with no major observed negative impacts

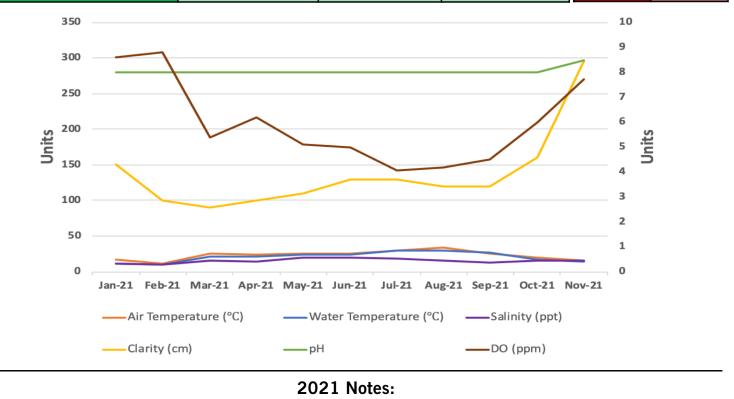
Bellinger Island; Site CW5

Standard	Score	Grade	Grading System	
Dissolved Oxygen	> 4 ppm	100%	Α	А	90-100
Secchi Depth	> 30 cm	100%	Α	В	80-89
рН	6.5-8.5	100%	Α	С	70-79
Temperature	< 32.2°C	100%	Α	D	60-69
Debris at Site		None	Α	F	0-59

- Calm & smooth waters at CW5 all season with no flooding
- Tannic, clear water
- No debris reported at this site!

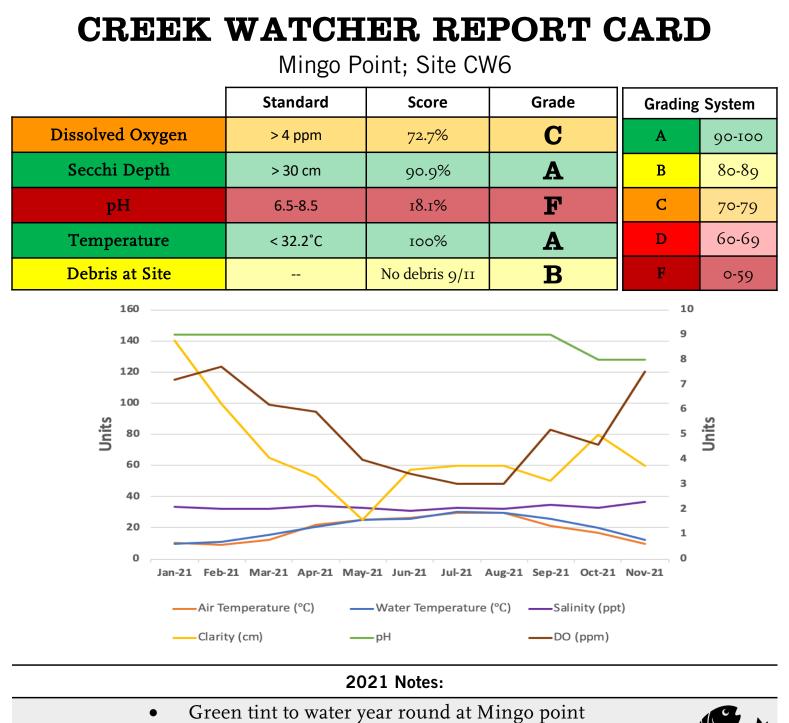
- Lots of organisms attached to the dock at this site!
- Rarely any debris for 2021

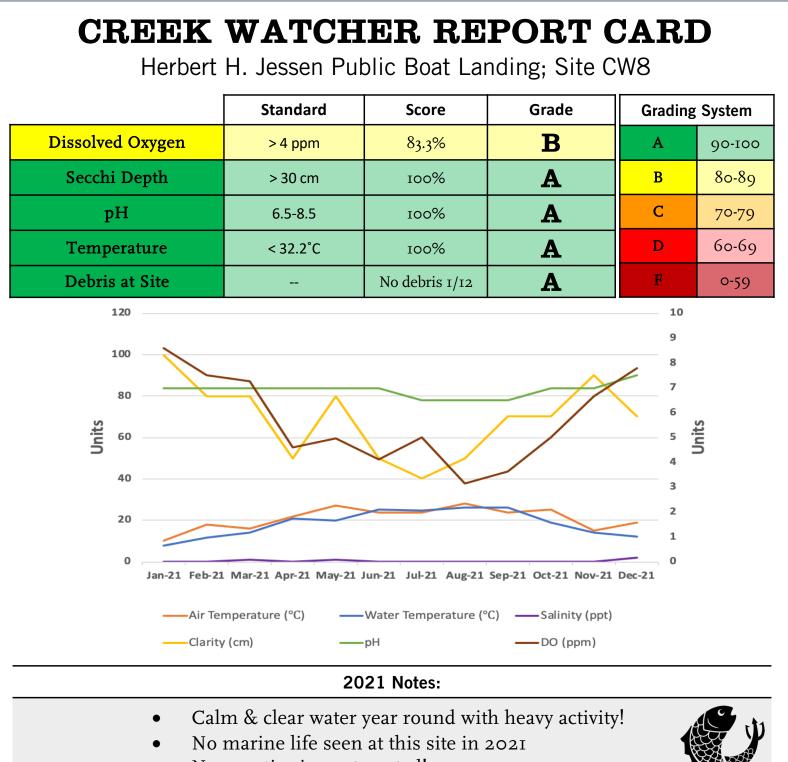
• No negative impacts noted!

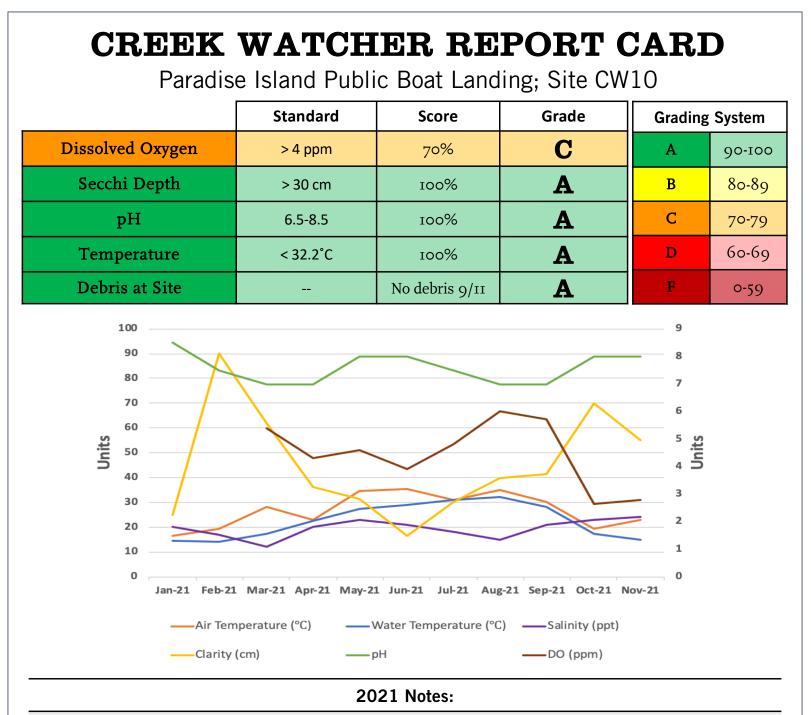
- Typically clear water with no tint
- Rarely any debris found at Paradise Island PBL
- Water movement year round at this site with recreational activity

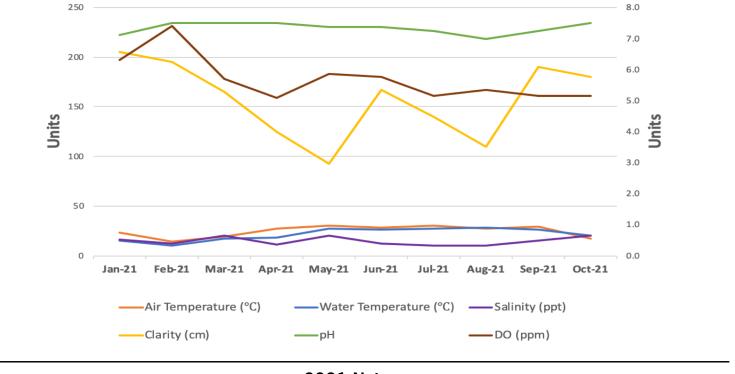
Noisette Creek; Site CW11

Standard	Score	Grade	Grading System	
Dissolved Oxygen	> 4 ppm	100%	Α	А	90-100
Secchi Depth	> 30 cm	100%	Α	В	80-89
рН	6.5-8.5	100%	Α	С	70-79
Temperature	< 32.2°C	100%	Α	D	60-69
Debris at Site		No debris 0/10	F	F	0-59

- Muddy waters at Noisette Creek year round
- Debris found at this site every month
- A lot of crabs, oysters, and snails found throughout the year!

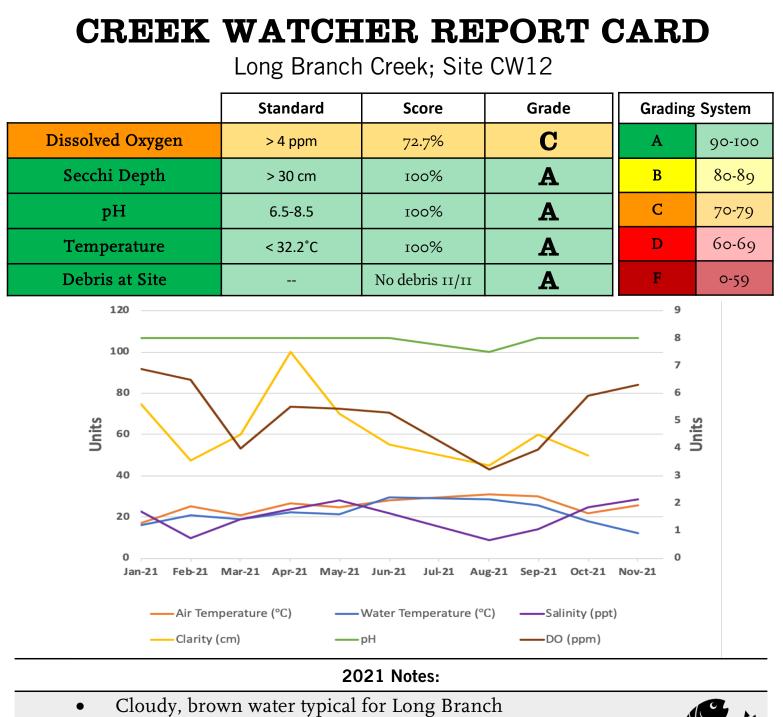
- No debris found all year!
- High spike in water clarity throughout the spring & summer

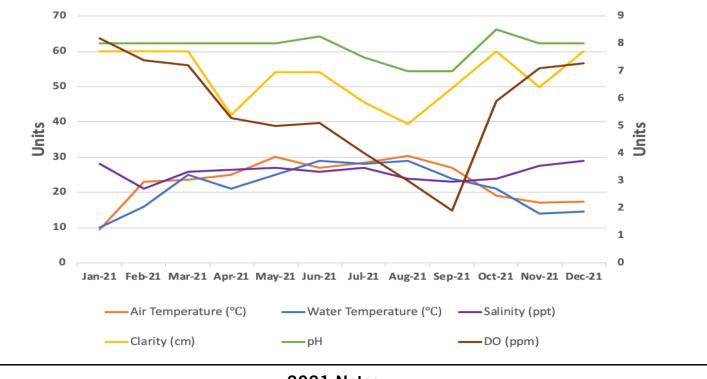
- Clear water throughout the year at Pitt Street Bridge in 2021
- A lot of snails found at this location through the summer
- No marine debris found in 2021!

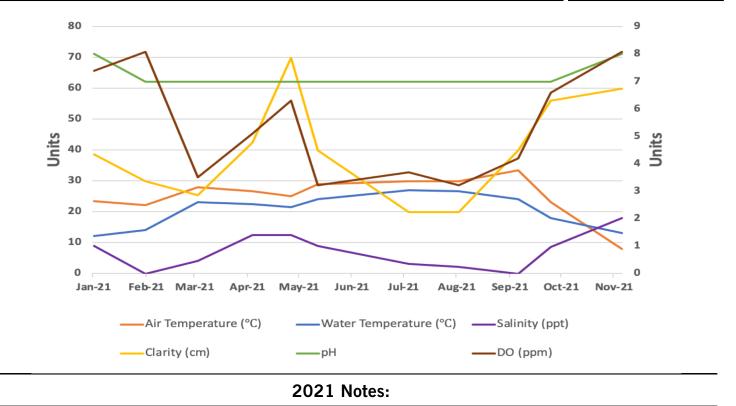
<b>CREEK WATCHER REPORT CARD</b> Pierpoint Public Boat Landing; Site CW14							
Standard Score Grade Grading System							
Dissolved Oxygen	> 4 ppm	63.6%	D	А	90-100		
Secchi Depth	> 30 cm	72.7%	С	В	80-89		
рН	6.5-8.5	100%	Α	С	70-79		
Temperature	< 32.2°C	90.9%	Α	D	60-69		
Debris at Site		No debris 6/11	D	F	0-59

- Calm & smooth water surface at Pierpoint PBL
- High recreational activity at this location
- A lot of debris found throughout 2021

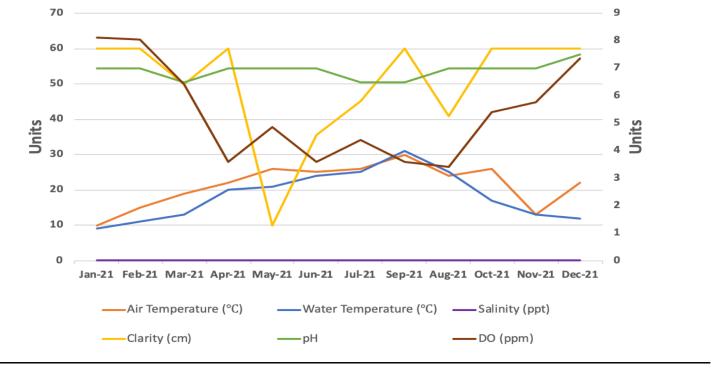
Bacon's Bridge; Site CW15

Standard	Score	Grade	Grading System	
Dissolved Oxygen	> 4 ppm	66.7%	D	А	90-100
Secchi Depth	> 30 cm	91.7%	Α	В	80-89
рН	6.5-8.5	100%	Α	С	70-79
Temperature	< 32.2°C	100%	Α	D	60-69
Debris at Site		No debris 12/12	Α	F	0-59

- Mix between clear and tannic/brown water at this site
- Clear water surface throughout the year
- Nearby construction possibly impacting this site in 2021
